SUB-SLAB DEPRESSURIZATION SYSTEM OPERATION, MAINTENANCE, & MONITORING (OM&M) PLAN

SOUTH DAYTON DUMP AND LANDFILL MORAINE, OHIO

2075 Dryden Road Moraine, Ohio

Parcel No. 5175, Building 17

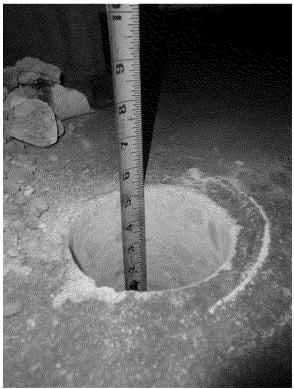
Photo 3: Conrete thickness at EP-1 stemline addition

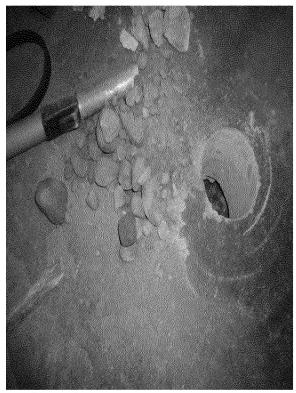
Photo 2: Aggregate removal at system EP-1 stemline addition

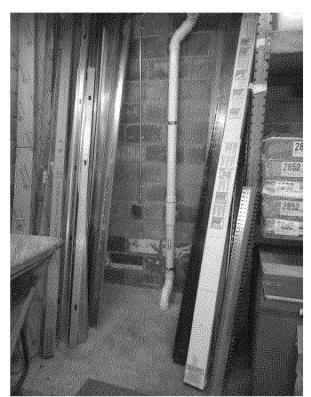
Photo 5: Suction point installated for system EP-1 with stemline addition

The four suction points (EP-1, EP-1 stemline, EP-2, and EP-2 stemline) were installed using 3-inch diameter Schedule 40 polyvinyl chloride (PVC) piping. Each suction point location was installed by coring a 4-inch diameter hole through the floor and concrete slab. The concrete slab had an average thickness of 6.4-inches, and the sub-slab soil was excavated to create at least a 6-inch void below the concrete slab. The sub-slab soil at the four suction points consisted of large cobbles and silty sand. The suction point piping was then sealed to the floor using waterproof silicone caulk. Each suction point extended vertically from the floor through the exterior wall to a 3-inch diameter PVC piping manifold. The PVC piping manifolds were sloped to each of the suction points such that any potential water condensate that accumulates during the SSDS operation would drain back beneath the sub-slab.
